Universal Design Walkability Audit Report

Kilrush, County Clare | 2020

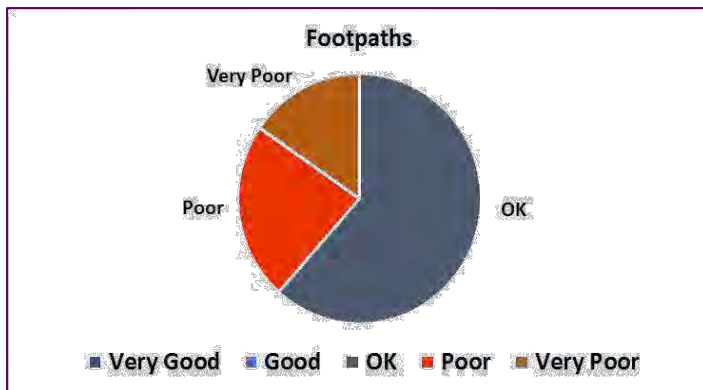
The footpaths were rated from 'Very Poor' to 'OK' by the participants, with more than half of the respondents rating them as 'OK'. None of the audit respondents rated the footpaths as 'Good' or 'Very Good'. A number of participants observed that the footpaths are in general very wide and this was welcomed. However, there was a lack of dropped kerbs on both routes audited, which caused difficulties for wheelchair users, who were participants in the audit.

In addition, the footpaths in general are poorly maintained and were hard for participants to negotiate, (refer to cluster map which shows the areas where no dropped kerbs exist) – it was evident that on both routes, wheelchair users were unable to access footpaths leaving them with no choice but to stay on the road, often with busy traffic passing.

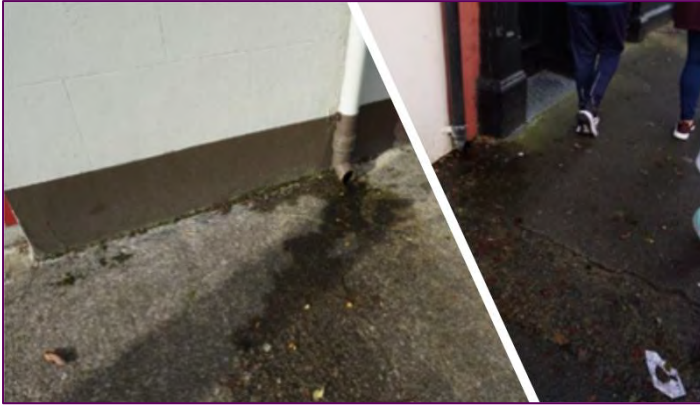
Figure 5 Photos highlighting an example of downpipe discharge onto the public footpath causing additional problems for older people and people with mobility issues. (Toler Street)

- **Action 9:** Identify the blackspot areas for rain-water pipes discharging onto the footpath and liaise with relevant stakeholders to repair the faulty downpipes.

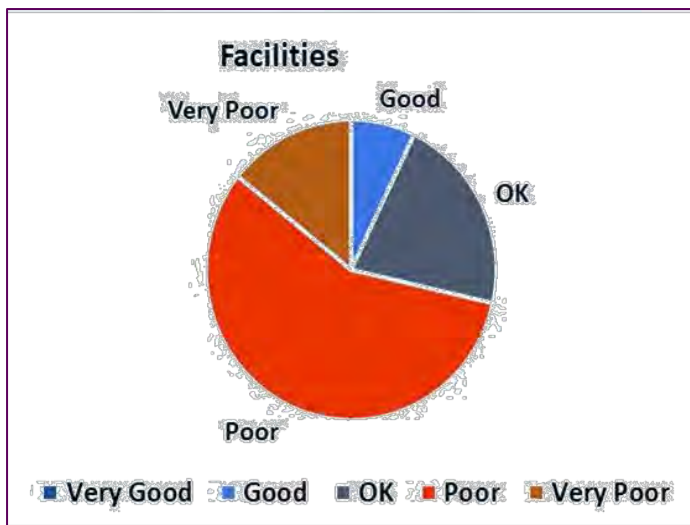
Facilities in Kilrush were deemed to be in the “Poor” and ‘Very Poor’ category by the majority of participants. There are some public seating and resting areas, but participants felt that the location and design of these spaces are in the wrong location. Bins and parking issues were generally perceived not to be a major issue, but the public toilet is located in an area that is difficult to access, as it is very hard to cross the road in Kilrush. Again, this was simply not possible for wheelchair users.

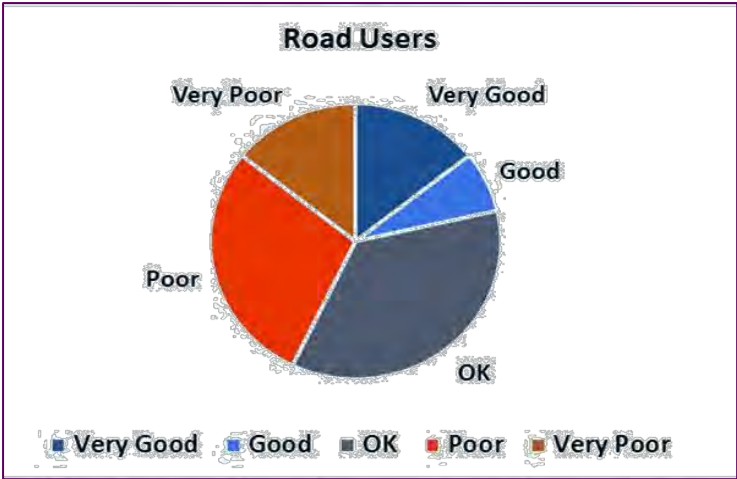
The Road User section had a mixed response from participants with responses ranging from ‘Very Poor’ to ‘Very Good’. This highlights the subjective nature of the participants’ perception of road user behaviour. More than half of the respondents gave a rating of ‘Poor’ or ‘OK’.

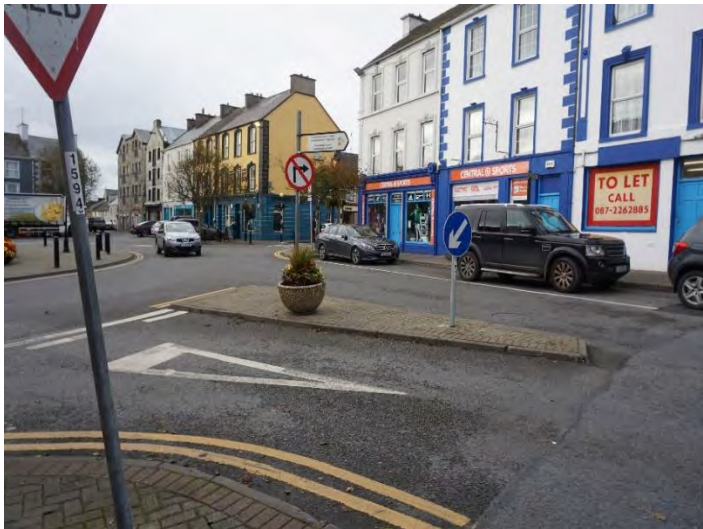
This photo highlights the wide roads surrounding Market Square. There is one dropped kerb onto this central area of the square, but it is not a defined pedestrian crossing, so it is very difficult to cross the road at this location. There is no clearly defined accessible pedestrian crossing for people that want to get to the central area of Market Square, where the public toilet is located.

- **Action 1:** Improve the provision of safe, accessible pedestrian crossing points, including pedestrian crossing(s) to access Market Square.

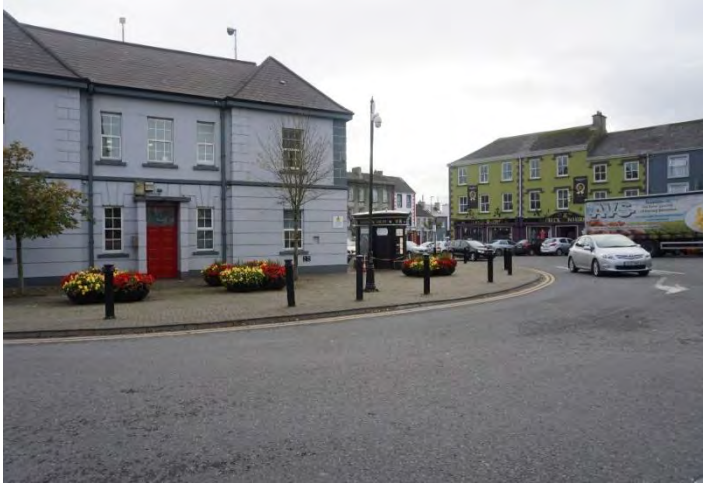
This photo highlights the challenge to cross from Burton Street at the junction with Market Square. The area is entirely car dominated and the pedestrian is subservient. There are no accessible crossing points with dropped kerbs and tactile paving.

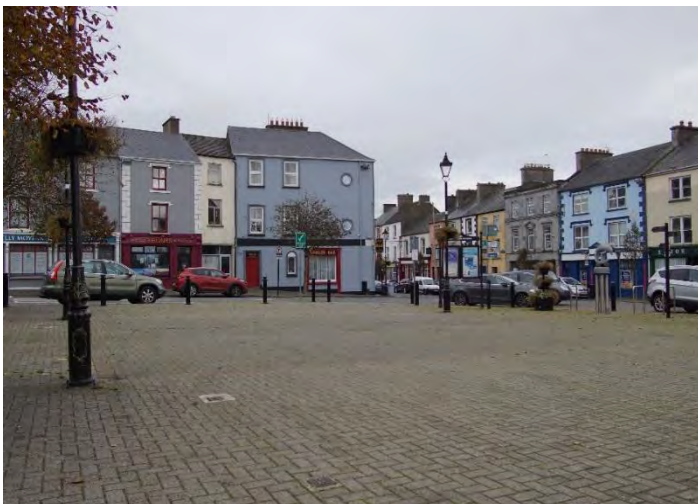
In this photo the grey building in the central area of Market Square contains the offices of West Clare Municipal District, and the only accessible public toilet in Kilrush is located to the right of the building. As above, there is no accessible pedestrian crossing to Market Square.

- **Action 8:** Improve the access to the existing public toilet by creating a safe pedestrian crossing to Market Square, this action is linked to Action 1 above.

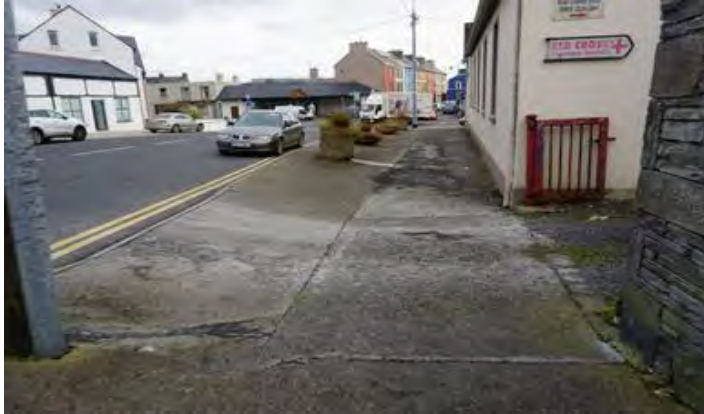
This Photo shows an uneven pathway with an inappropriate slope and lack of maintenance. This area is particularly poor and hard for pedestrian and vulnerable road users to navigate. (Fahy's Road).

Provide dropped kerbs and tactile paving at pedestrian crossing points and design a priority list for footpath repair works in conjunction with the relevant stakeholders.

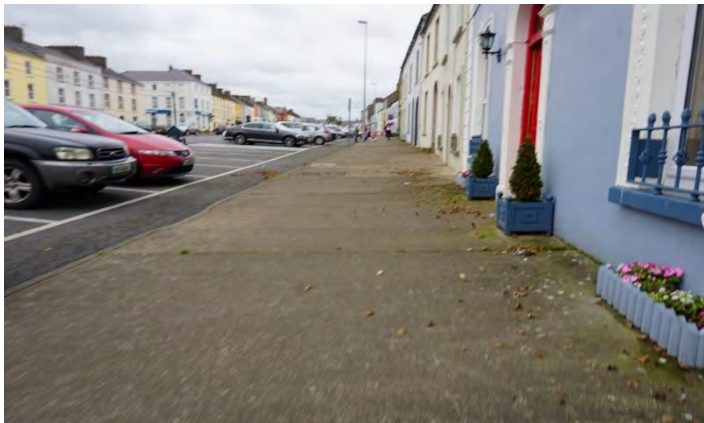
The footpaths are generally wide, which is a positive element. (Frances Street)

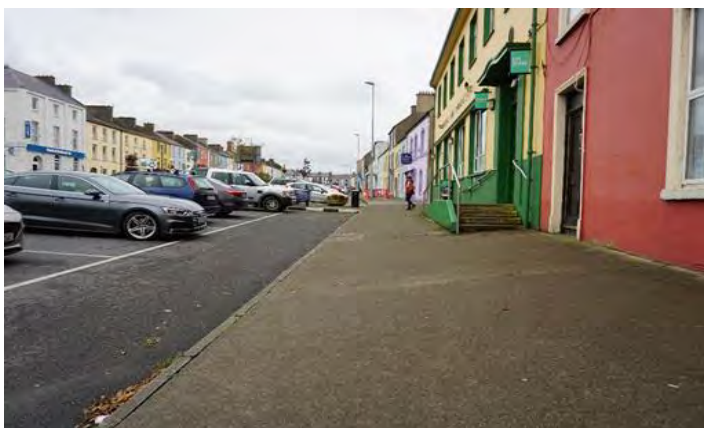
Despite being wide, in some places the footpaths have a severe slope that participants found hard to walk. In this photo, the sloped concrete footpath is quite steep. (Outside Post Office on Frances Street)

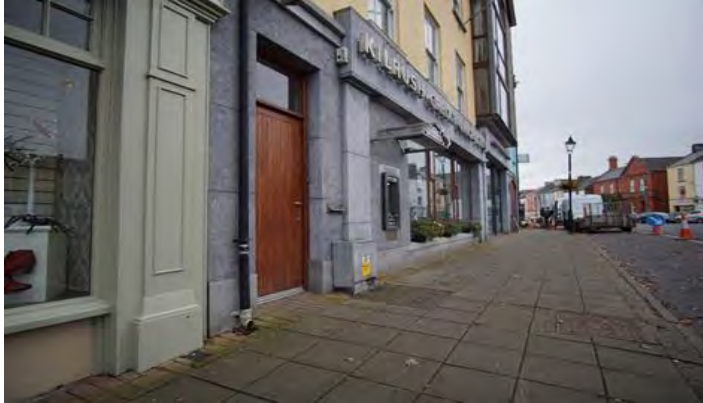
Again, another example that despite being wide, the sloped paved footpath is quite steep, and this path is a more recent addition to the streetscape of Kilrush. (Outside Credit Union on Frances Street).

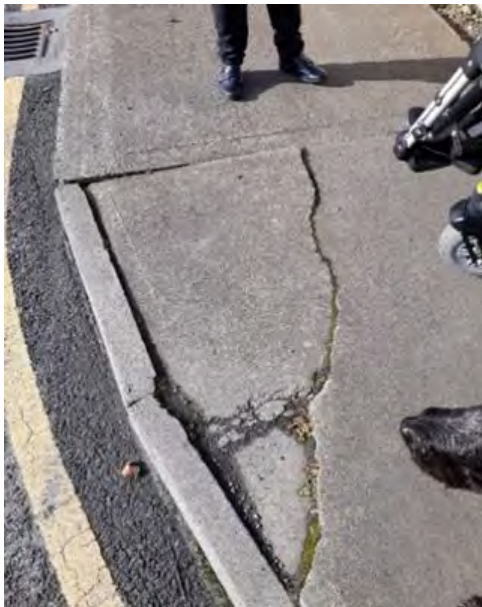
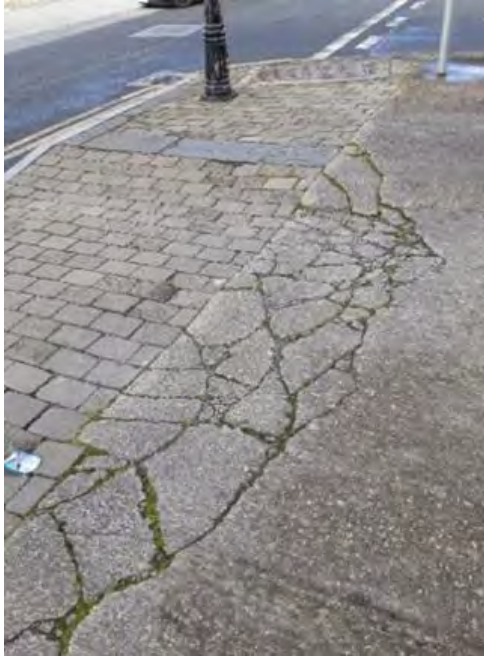
The two photos here are examples of the poor quality of footpath finish. Historic poor maintenance and general lack of investment in the public realm has allowed this path to fail over time. (Fahy's Road).

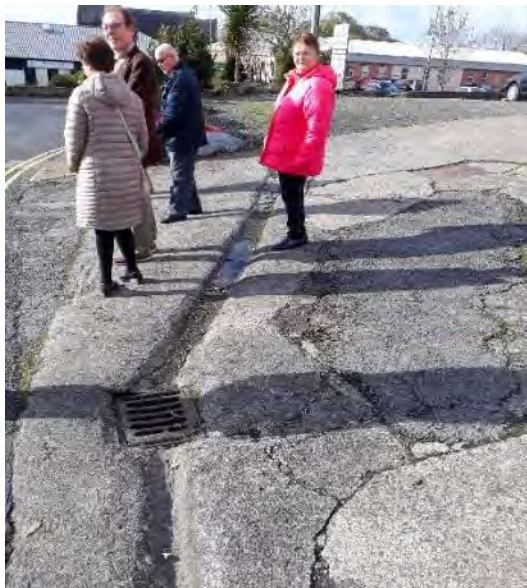
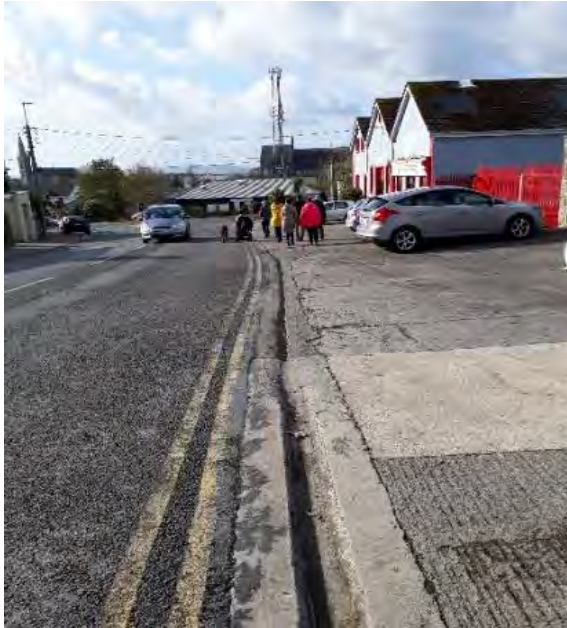
Historic gullies are evident in Kilrush, which would indicate an engineering solution of considerable age. (Fahy's Road and Cooraclare Road)

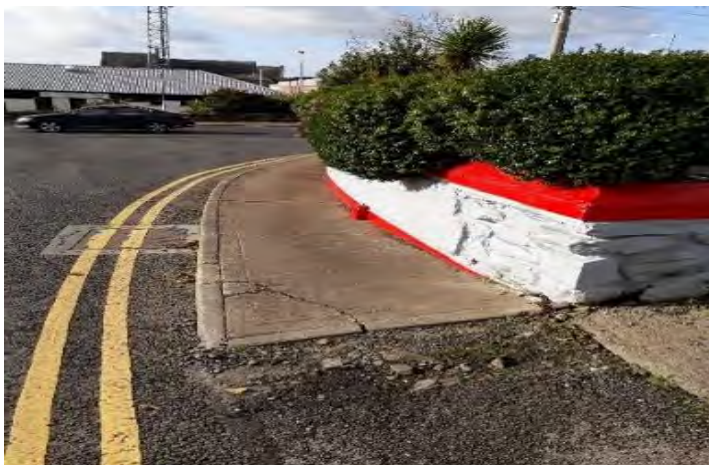
This example of a complete contrast in paving materials – changing from concrete to tarmacadam could cause distress to persons with Dementia. To a person with dementia this change in contrast can appear as a hole and increases the person's confusion. Strong contrast changes such as this example should be avoided.

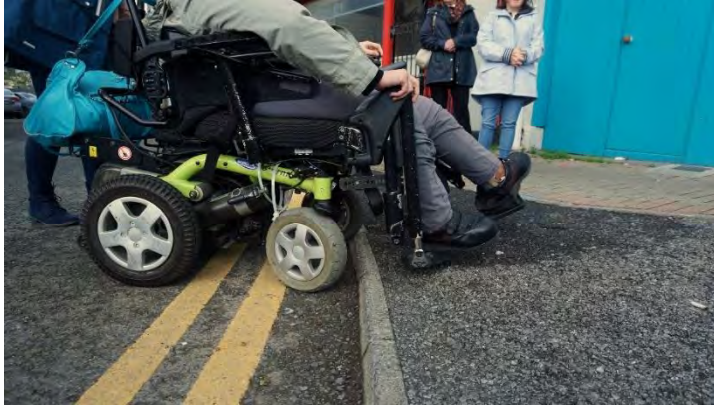
This photograph highlights the difficulty that the lack of dropped kerbs creates for a wheelchair user. Unless Kilrush can be entirely accessible for people with reduced mobility, they will continue to have difficulty accessing the services and facilities in the town. (Market Square)

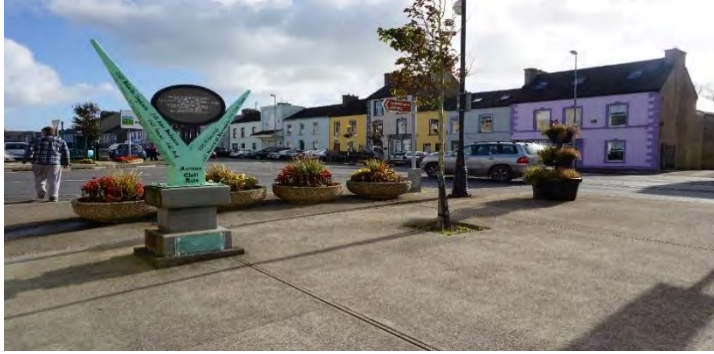
A nice sunny spot but no seating. This would be a convenient place for some public seating. (Near Super-Valu, Frances Street)

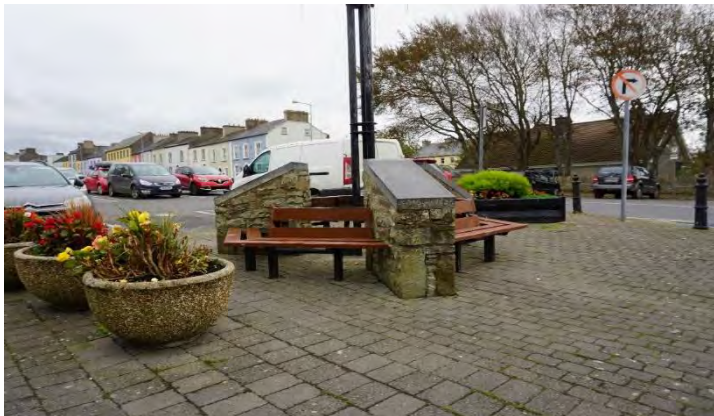
Participants liked this seating in Kilrush – well sheltered, comfortable and plenty to see. (Frances Street)

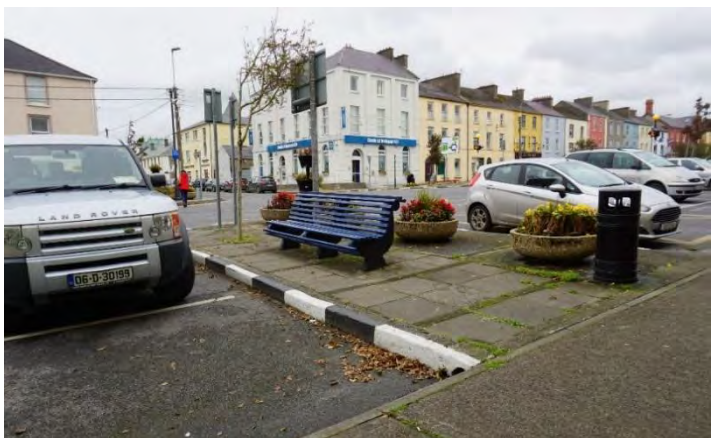
The location of public seating is very important. The local micro-climate of a particular area will determine whether seat location is successful or not. This seat is located in a cold, windy spot with seating which does not have any armrests and does not appear to be a popular spot. (Near Post Office, Frances Street)

Any public seating provided should follow the guidelines and recommendations set out in the following documents.

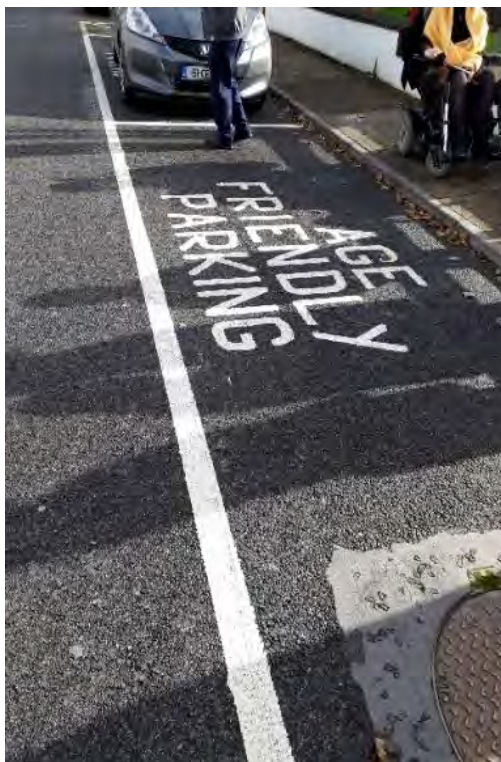
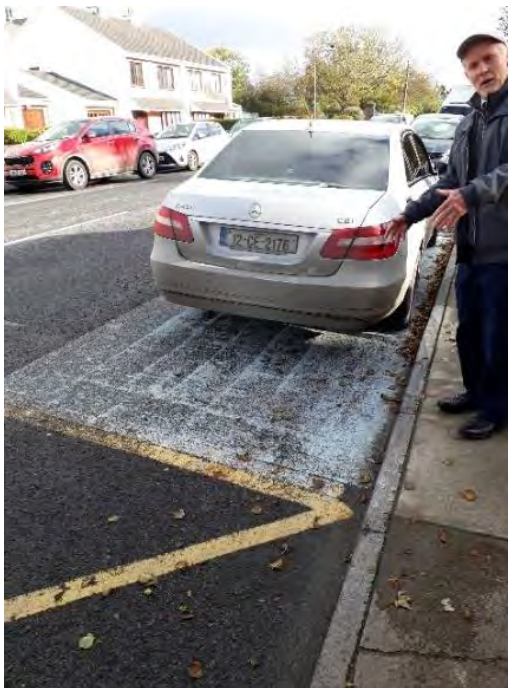
A photo of the Age Friendly Car Parking directly outside the Community Centre, Back Road. Kilrush does have some accessible parking areas but considering the high percentage of persons registered with a disability, more spaces are required. It is also evident that in some cases, the markings that highlight the availability of accessible spaces are faded and not fit for purpose.

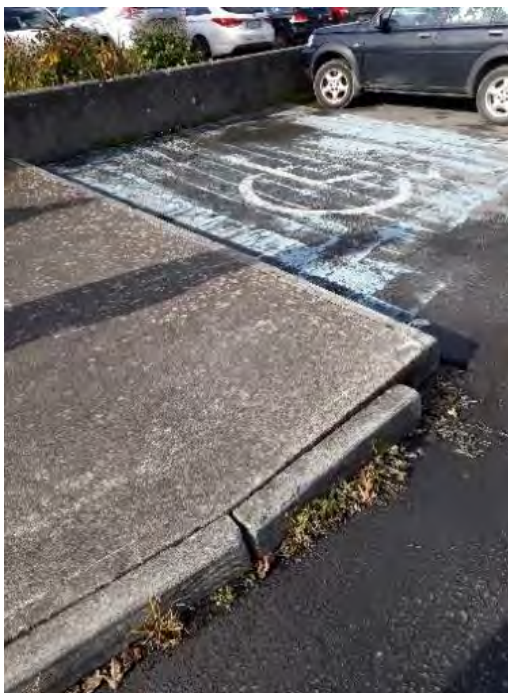
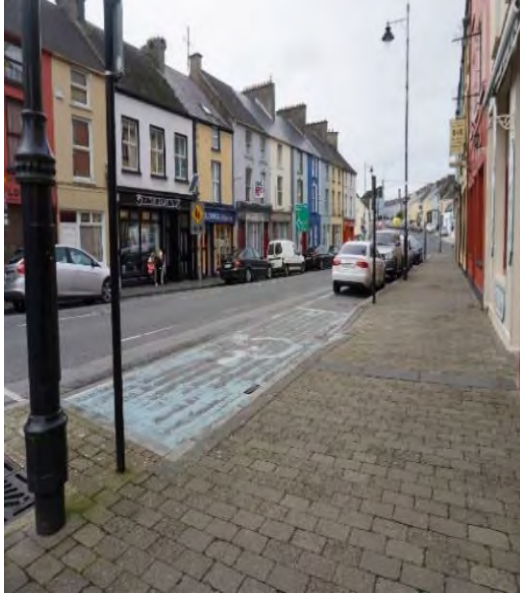
Photos highlight the poor visibility of existing accessible parking spaces, as the markings are poorly maintained. (Frances Street and Moore Street)

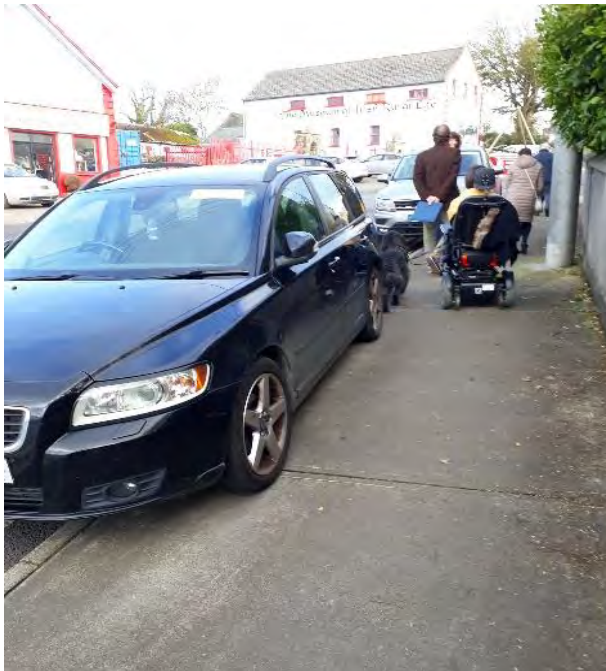
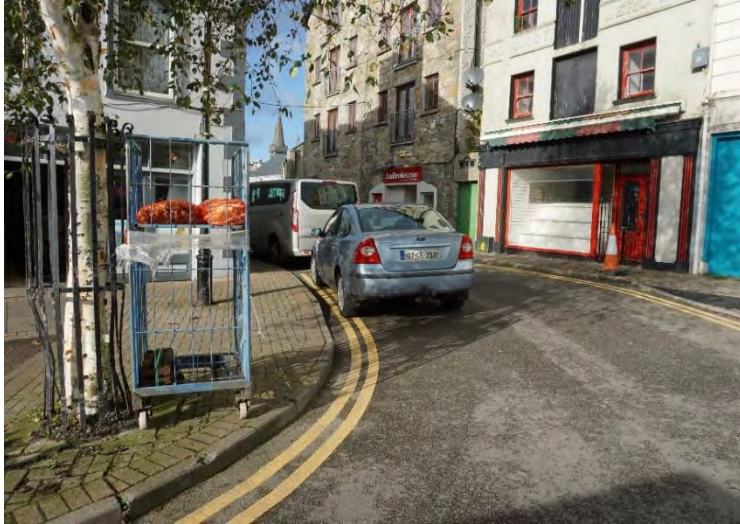
These photographs highlight the inconsiderate nature of “temporary” car parking – parking that people do just for a few minutes. (Fahy’s Road)

Inconsiderate parking is a regular and “normal” occurrence in Kilrush, despite considerable dedicated parking on Main Street. In the second photograph, there was plenty of dedicated parking 80 metres away. (Market Square)

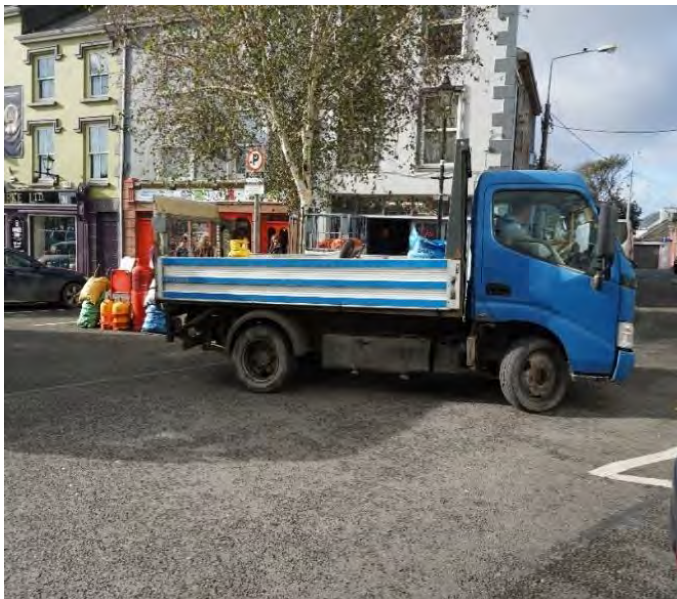
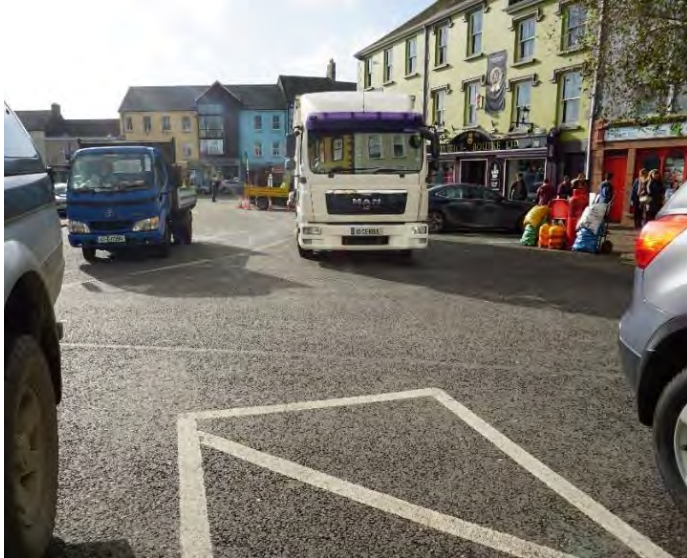
The photos above show that the area around Market Square is busy, which is a positive element in Kilrush. However, inappropriate deliveries, which are entirely inconsiderate to pedestrians are a regular occurrence in Kilrush. This appears to be a habitual practice, normally undertaken on a regular basis by deliveries which “only take a couple of minutes”. It is the cumulative impact of all the deliveries which causes frustration and inconvenience for pedestrians.

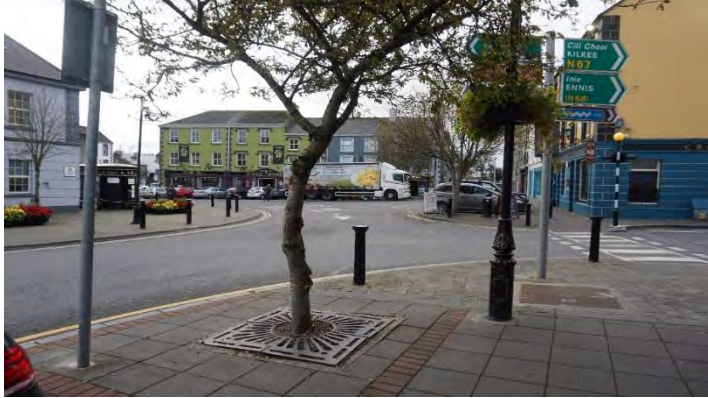
This area is too congested, especially for persons with reduced mobility or low vision. (Market Square)

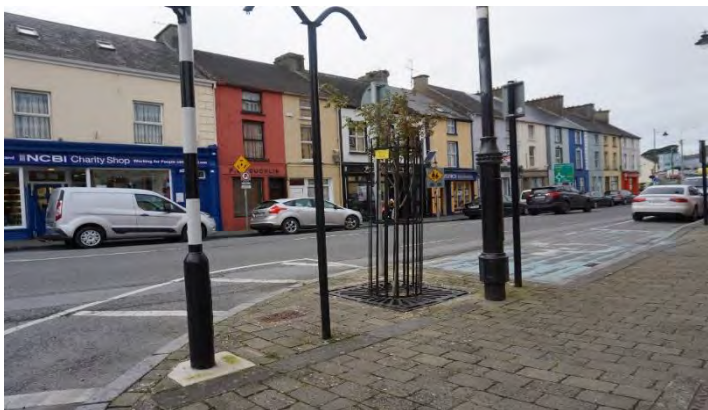
Another example of excessive street clutter. (Moore Street)

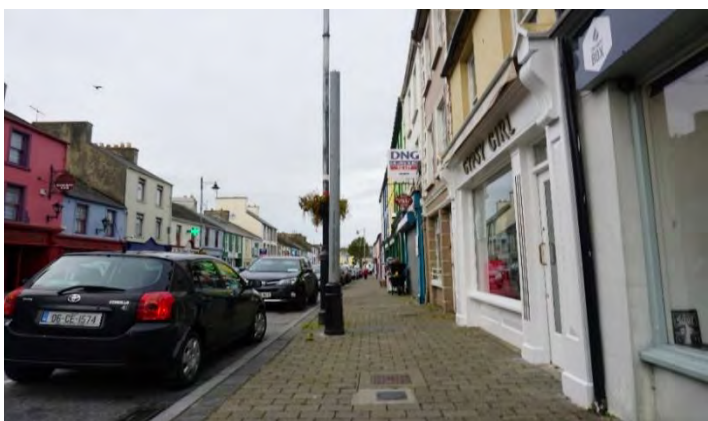
The placement of utility poles and boxes needs to be carefully designed to avoid impact on pedestrians. (Henry Street)

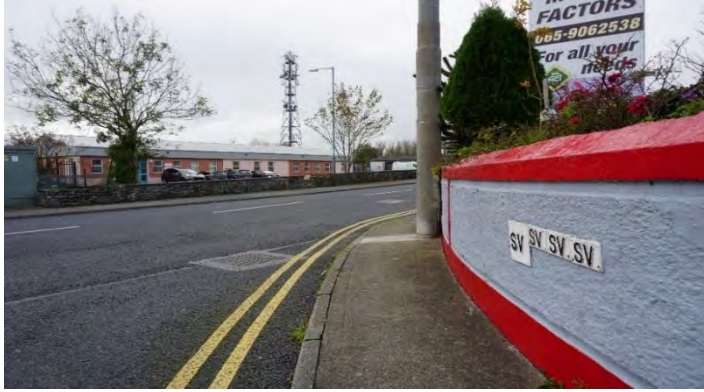
This pole is in a very inappropriate place. (Fahy's Road at the roundabout)

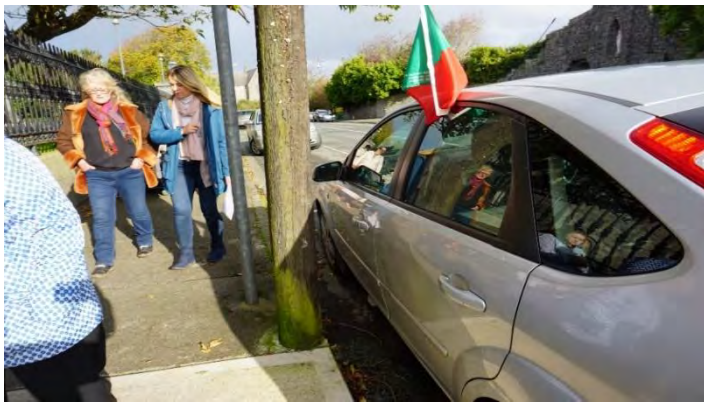
Another example of excessive street clutter. (Moore Street)

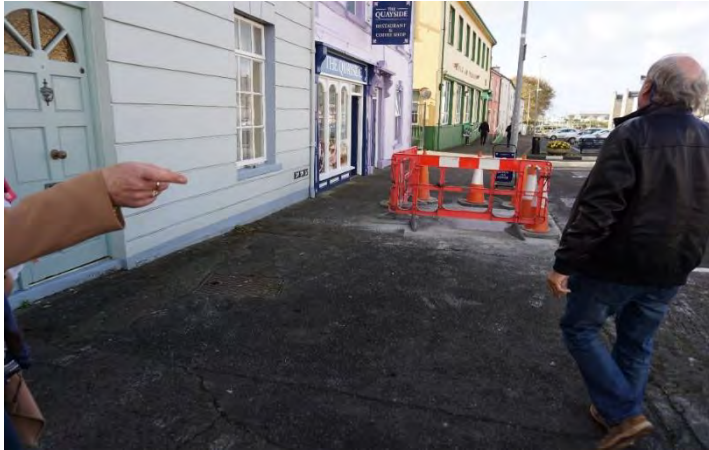
This photo highlights the impact of temporary works on people with mobility issues, the condition of the footpaths adds to the problem. In this photo, the temporary works have left less than one-third of the footpath for pedestrians. This barrier had been in place for two weeks on the day of the audit. (Frances Street)

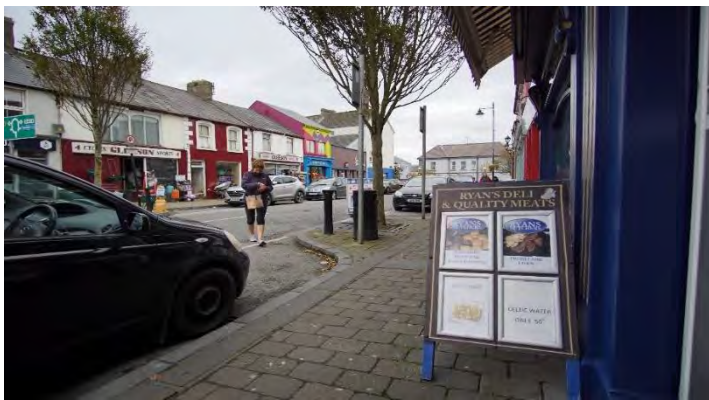
While businesses can be well meaning, the impact of on-street sandwich boards can have a detrimental impact on the walkability of an area, especially for people with sight or mobility difficulties. (Henry Street)

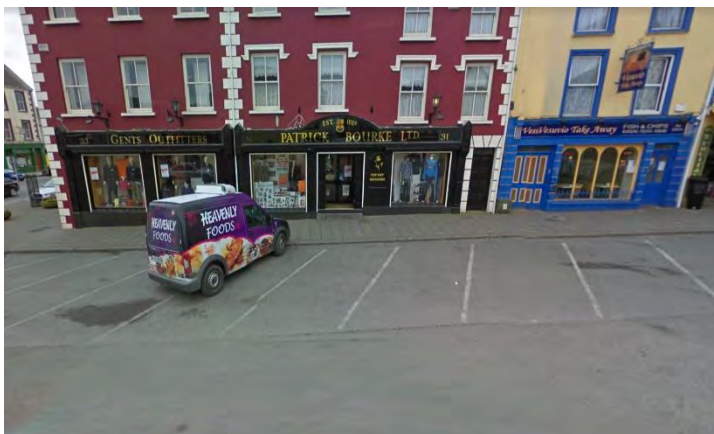
The Bus Stop for Kilrush is outside Patrick Bourke’s on Market Square. There are no seats, no signs, no dedicated area to wait. Participants were very vocal on this issue.

- **Action 7:** Investigate the potential of an urban re-design to improve the public realm at this Market Square with the relevant stakeholders, including the provision of facilities at the bus-stop.

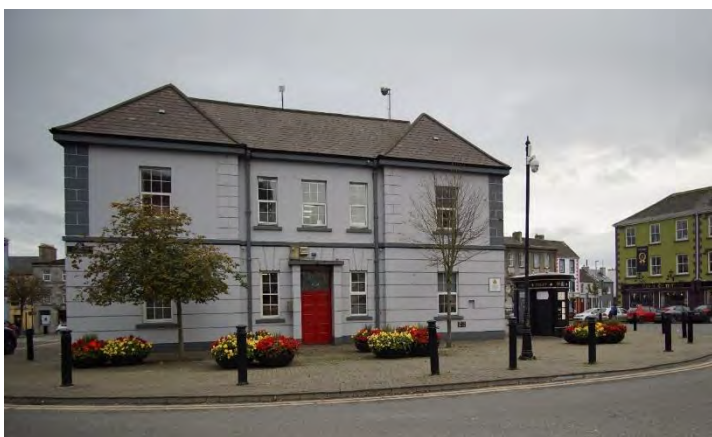
The public toilet is situated on Market Square. Market Square is hard to get to for pedestrians, because of difficulty crossing the road.
